Foundation Report

**Thomas Creek, Richardson Gap Road
(Shimanek) Covered Bridge
County Bridge No. BR0637-0070
ODOT Bridge No. 12965, Key No. 20314**

Linn County, Oregon

February 12, 2019

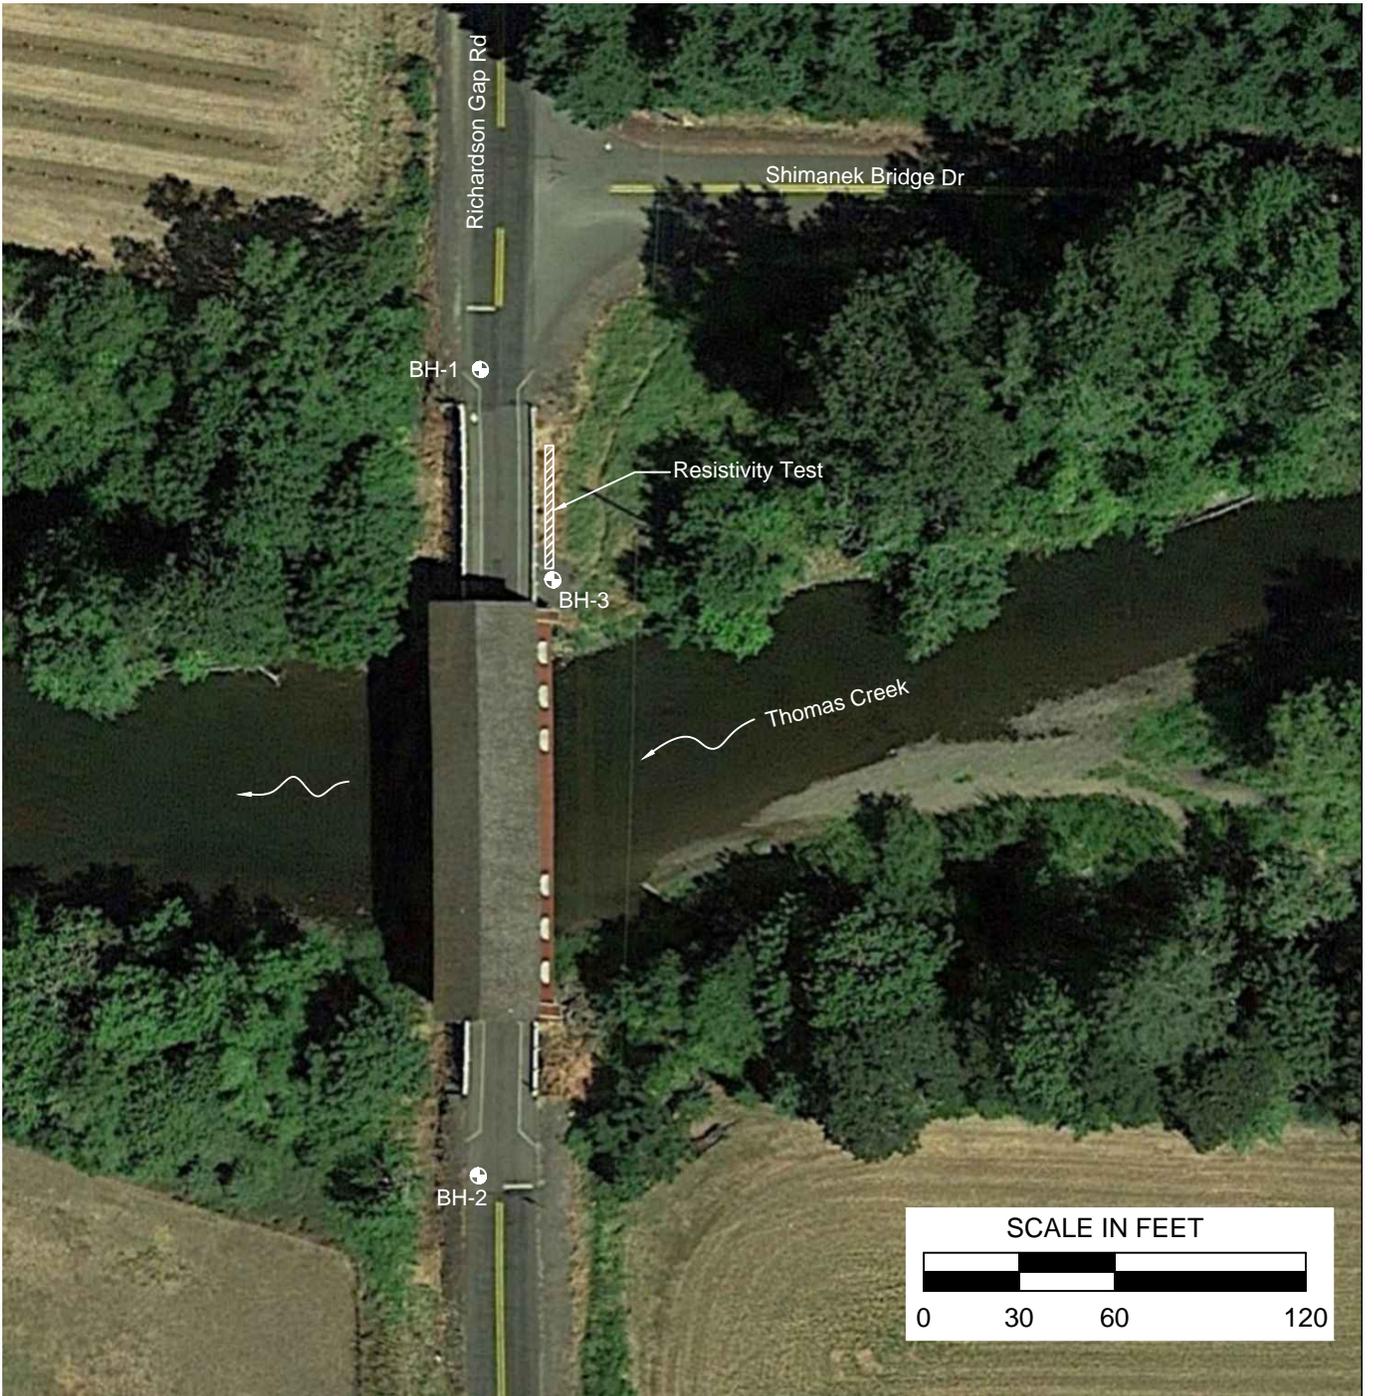
2A

1. BORING LOCATIONS WERE NOT SURVEYED AND WERE ESTABLISHED USING A TAPE MEASURE REFERENCING EXISTING LANDMARKS. LOCATIONS ARE APPROXIMATE ONLY.
2. SEE MEMO FOR A DISCUSSION OF SUBSURFACE CONDITIONS.
3. AERIAL IMAGE OBTAINED FROM GOOGLE EARTH.

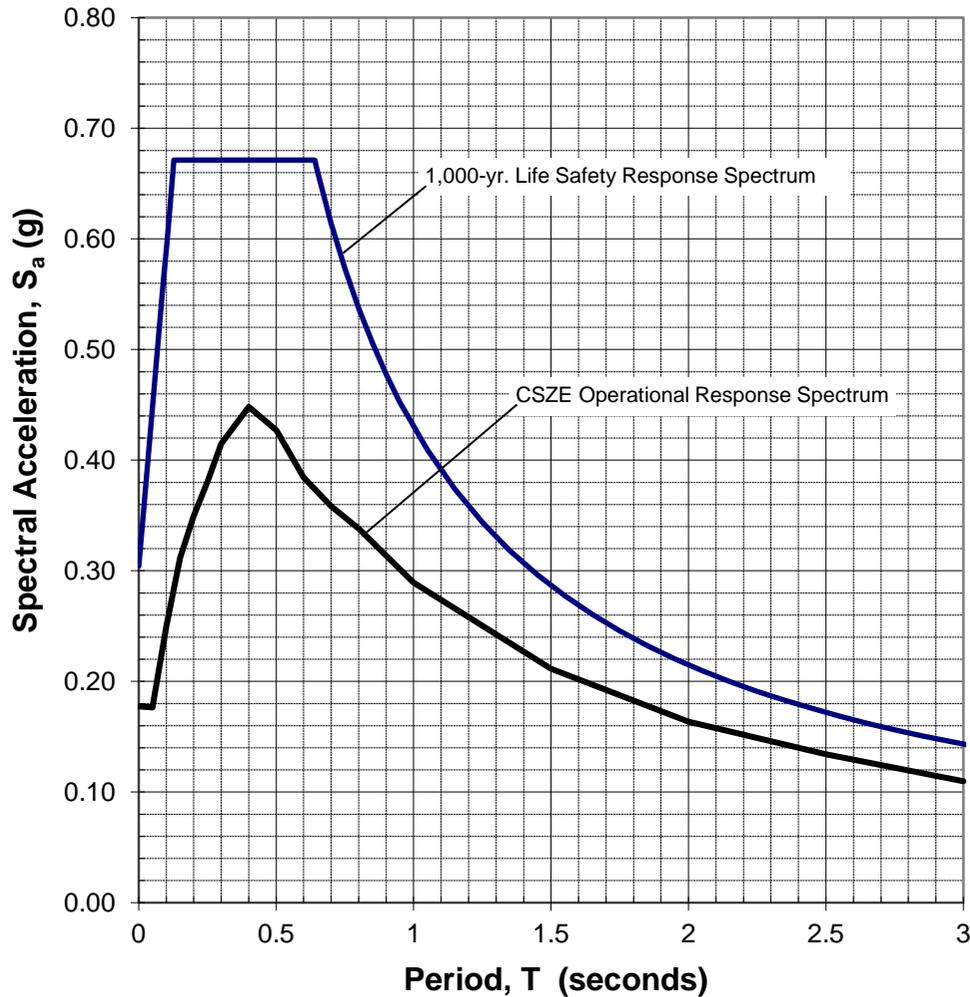
1. The 1,000-yr. Life Safety Design Response Spectrum is based on AASHTO 2014 Section 3.10.3 using the following parameters:

PGA, S_s and S_1 values are based on USGS 2014 seismic hazard maps and were obtained using the ODOT ARSV2014.16.xls spreadsheet. F_{pga} , F_a , and F_v were established based on ODOT GDM 2016, Tables 6.2-A, 6.2-B and 6.2-C using the selected PGA, S_s , and S_1 values.

Response spectra for the site were developed based on the 2018 ODOT Geotechnical Design Manual (GDM) "life-safety" and "operational" criteria. The "life-safety" (i.e., no collapse) seismic performance criteria assumes earthquake ground motions having a 1,000-year average return period. The "operational" (i.e., remain in service) criteria assumes a full-rupture Cascadia Subduction Zone Earthquake (CSZE) event. The response spectra and design parameters are shown on Figure 3A (Appendix A).

The ground motions for the 1,000-year return period life-safety response spectrum were developed using the General Procedure in the AASHTO LRFD Bridge Design Specifications (2014), with modifications recommended in the 2017 ODOT GDM. The ground motion parameters, including peak ground accelerations (PGA), short period (0.2 second) spectral accelerations (S_s), and long period (1.0 second) spectral accelerations (S_1) on bedrock were calculated using the ODOT ARS V 2014.16 spreadsheet, which is based on the 2014 USGS seismic hazard maps (Peterson et al., 2014). Following the AASHTO General Procedure, the spectral accelerations on bedrock were scaled to the ground surface using F_{pga} , F_a , and F_v values appropriate for the Site Class. The Site Class accounts for the average subsurface conditions within 100 feet of the ground surface. The subsurface conditions at the bridge site correspond most closely to a Site Class D based on the subsurface profile and depth-averaged SPT N-values documented in the borings. The scaling factors were selected based on ODOT GDM Tables 6.2-A, 6.2-B, and 6.2-C.

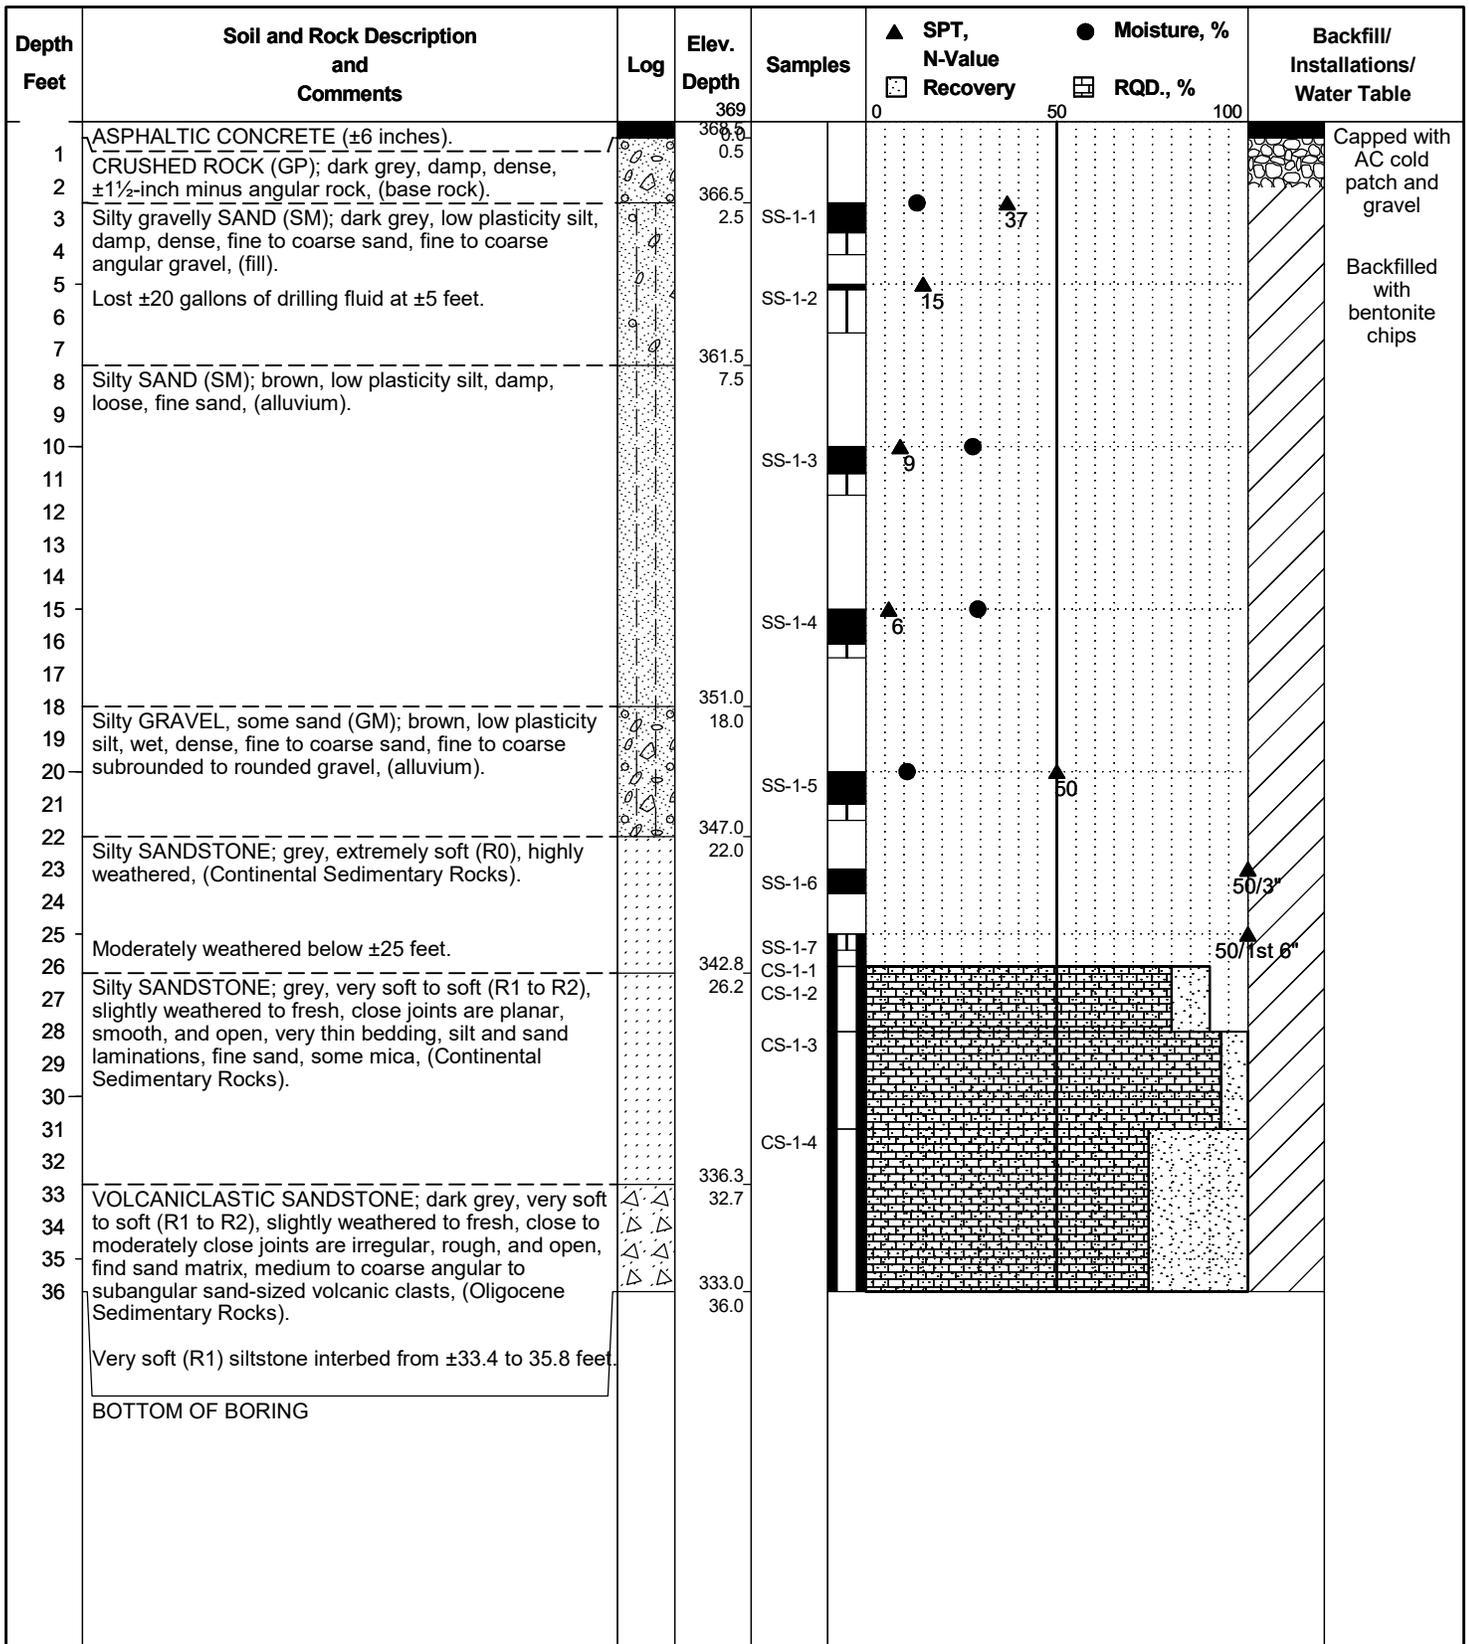
Surface Elevation: 369.0 feet (Approx.)

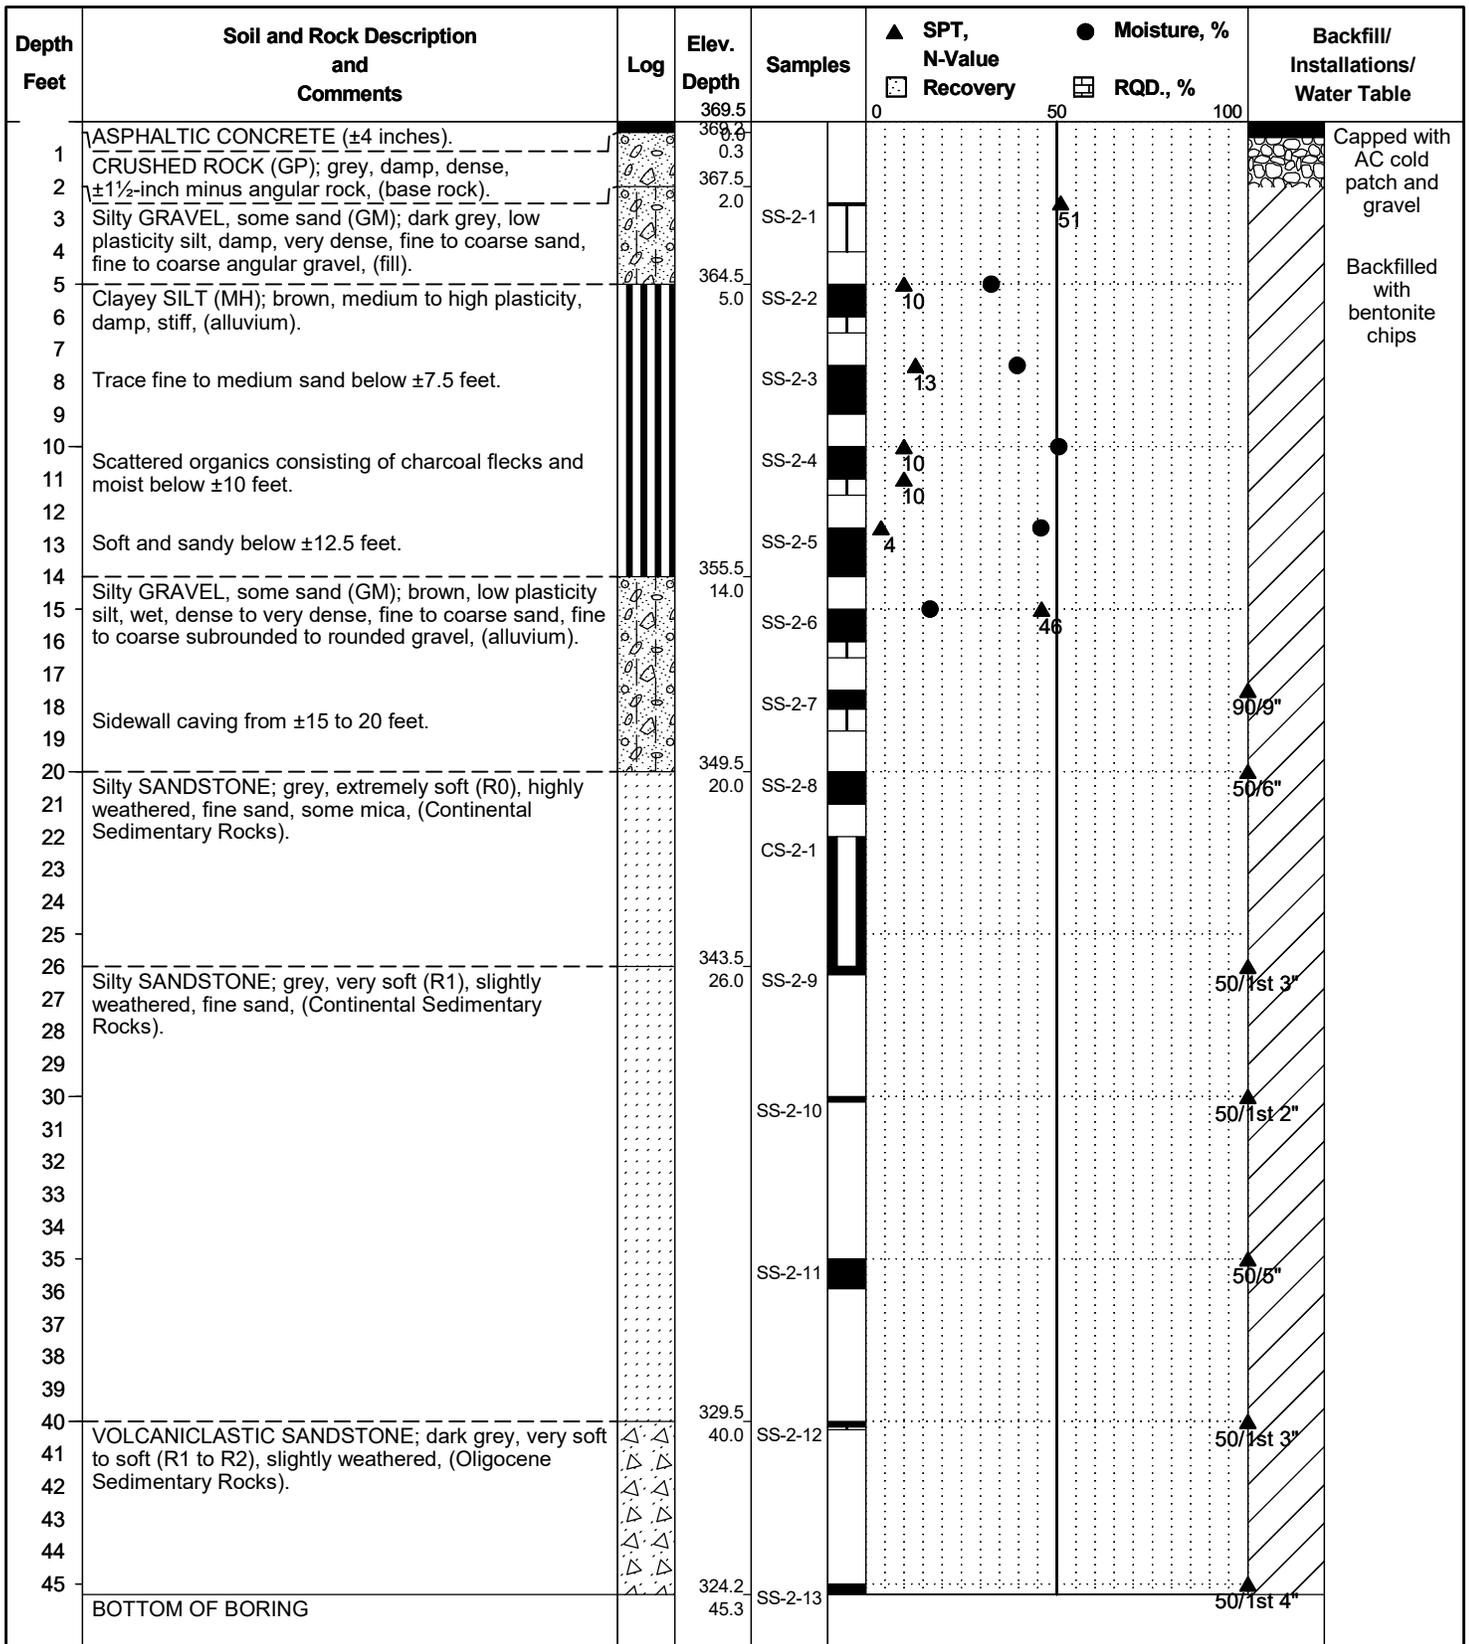
Surface Elevation: 369.5 feet (Approx.)

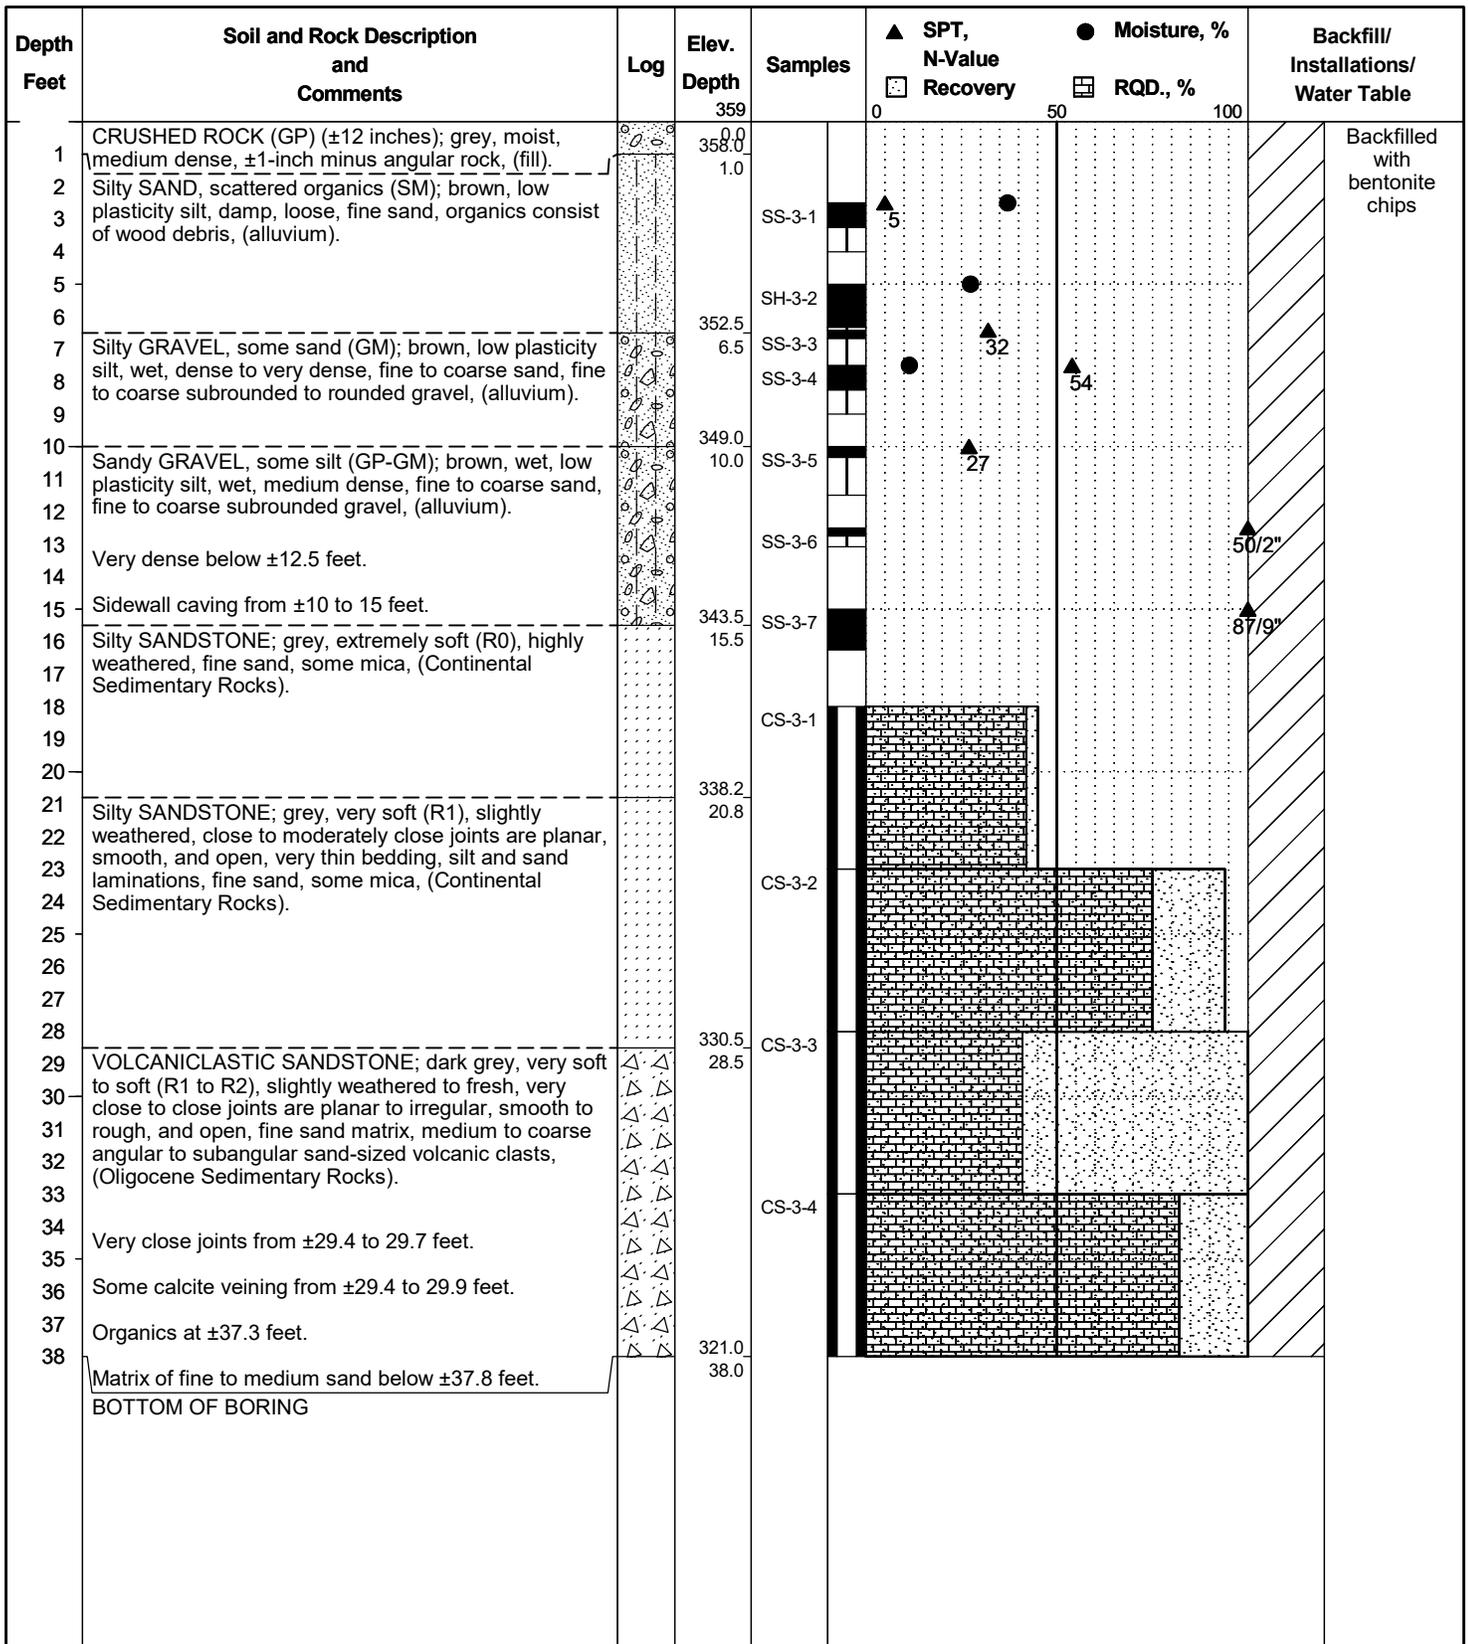
Surface Elevation: 359.0 feet (Approx.)

3.2.2. Bent 3 (North Covered Bridge Pier) – BH-3: The ground surface at BH-3 lies at ±El. 359.0. The ground surface is covered with ±12 inches of medium dense, ±1-inch minus crushed rock (fill). Alluvium extends below the fill and consists of loose silty sand to ±6.5 feet (±El. 352.5), dense to very dense silty gravel with some sand to ±10 feet (±El. 349.0), and medium dense to very dense sandy gravel with some silt to ±15.5 feet (±El. 343.5), the approximate bedrock surface.

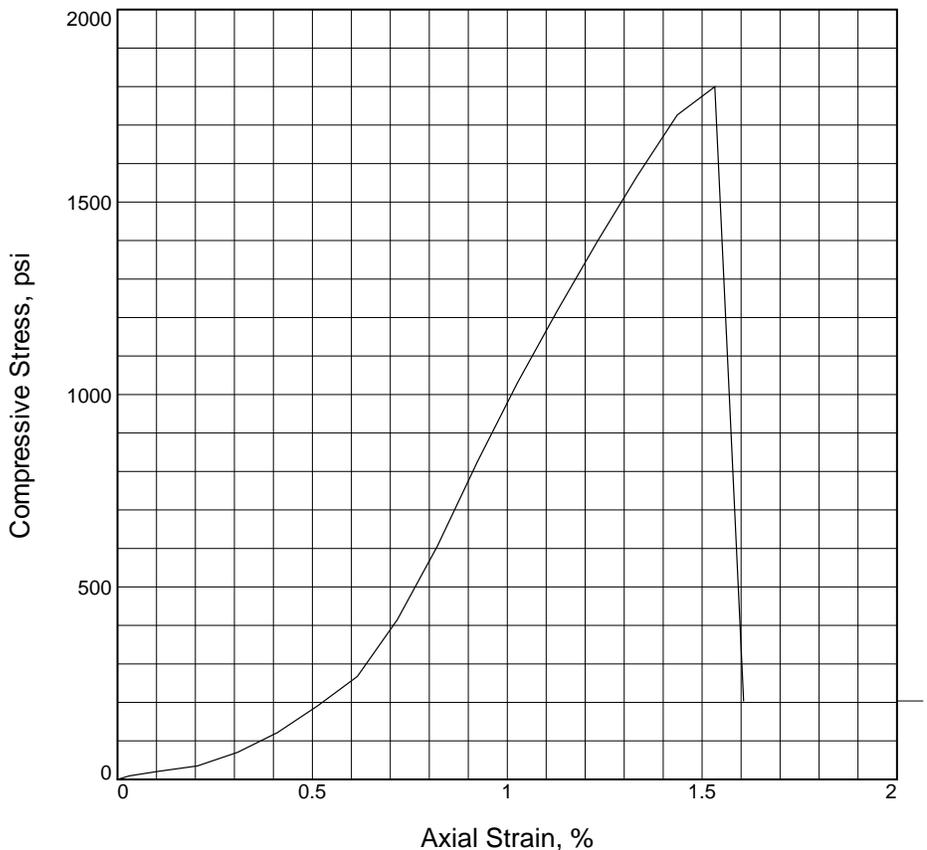
Figure 1C

Sample No.	1			
Unconfined strength, psi	1799.60			
Undrained shear strength, psi	899.80			
Failure strain, %	1.5			
Strain rate, in./min.	0.005			
Water content, %	31.1			
Wet density, pcf	118.2			
Dry density, pcf	90.2			
Saturation, %	98.6			
Void ratio	0.8347			
Specimen diameter, in.	2.01			
Specimen height, in.	4.87			
Height/diameter ratio	2.43

Description: Grey, soft (R2) silty sandstone

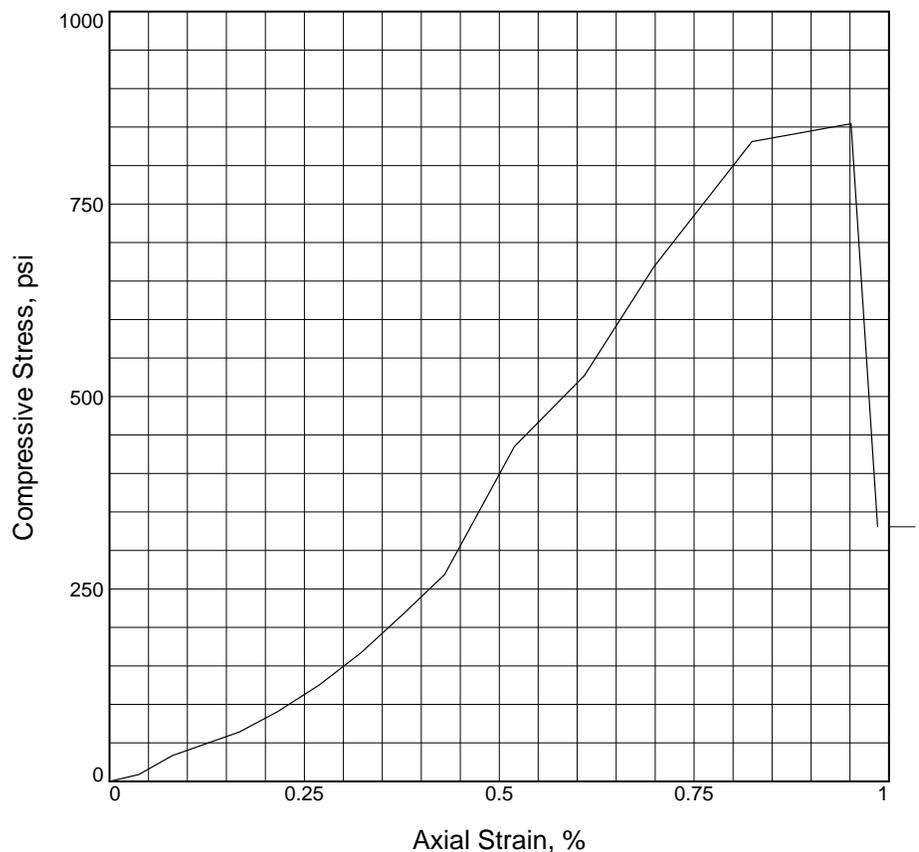
Figure 2C

Sample No.	1			
Unconfined strength, psi	854.37			
Undrained shear strength, psi	427.19			
Failure strain, %	1.0			
Strain rate, in./min.	0.006			
Water content, %	33.9			
Wet density, pcf	112.6			
Dry density, pcf	84.1			
Saturation, %	92.9			
Void ratio	0.9667			
Specimen diameter, in.	2.39			
Specimen height, in.	5.58			
Height/diameter ratio	2.33

Description: Grey, very soft (R1) silty sandstone

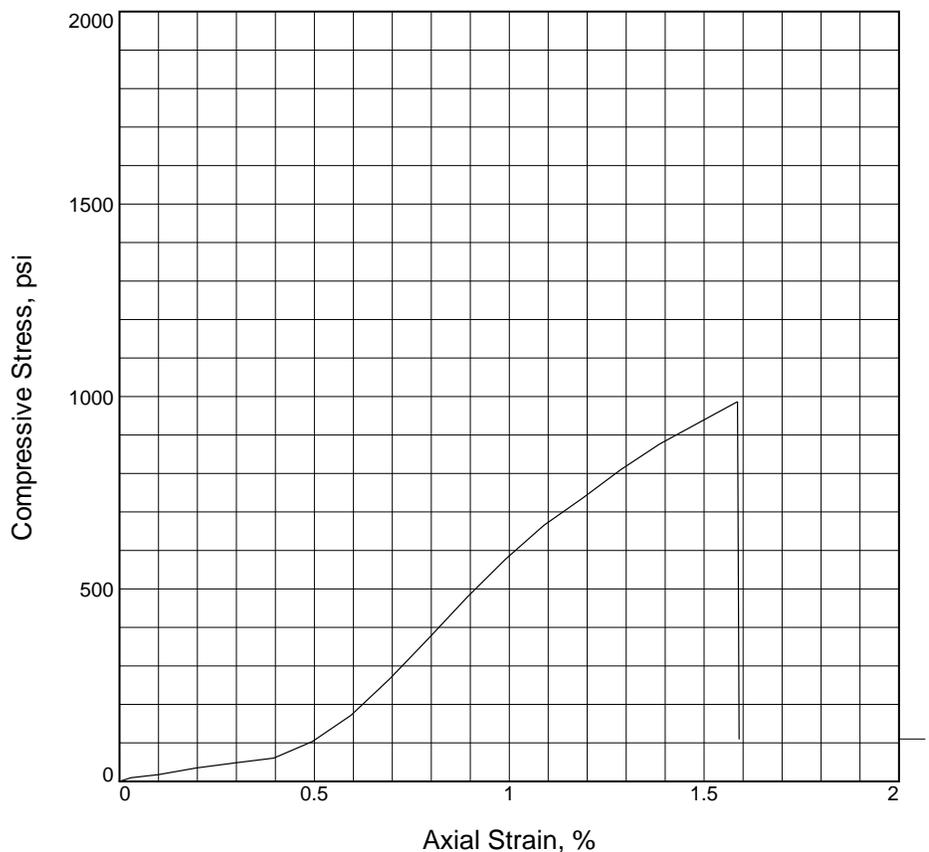
Figure 3C

Sample No.	1			
Unconfined strength, psi	985.84			
Undrained shear strength, psi	492.92			
Failure strain, %	1.6			
Strain rate, in./min.	0.005			
Water content, %	30.0			
Wet density, pcf	118.7			
Dry density, pcf	91.3			
Saturation, %	98.0			
Void ratio	0.8115			
Specimen diameter, in.	2.39			
Specimen height, in.	5.05			
Height/diameter ratio	2.12

Description: Grey, very soft (R1) silty sandstone

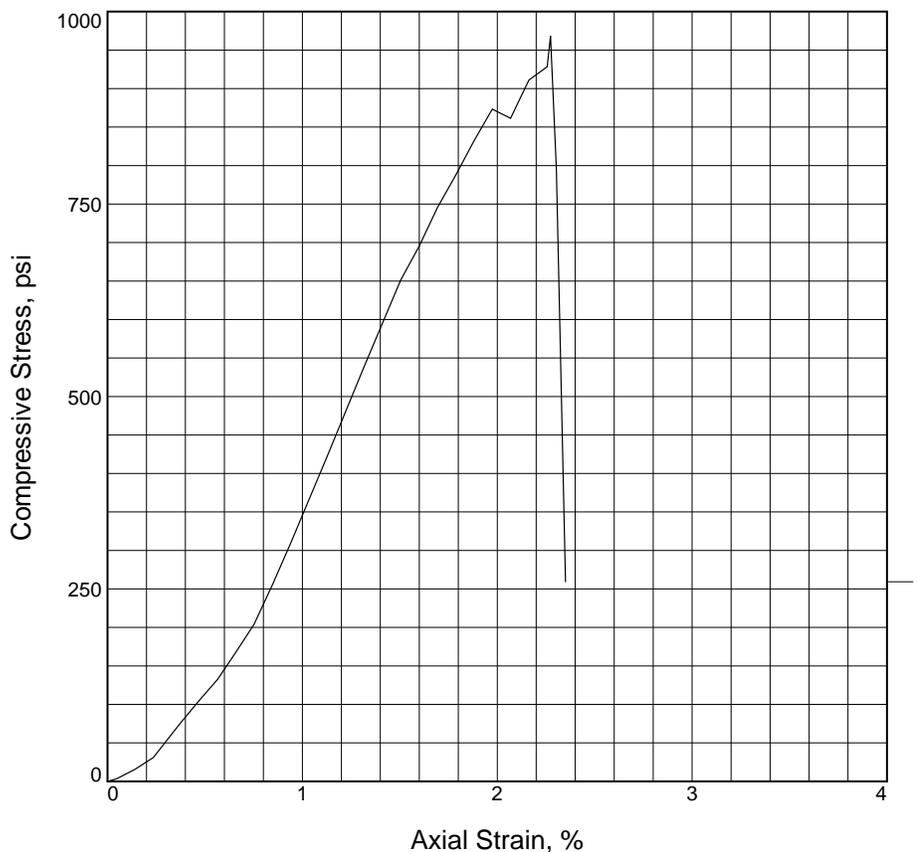
Sample No.	1			
Unconfined strength, psi	968.37			
Undrained shear strength, psi	484.19			
Failure strain, %	2.3			
Strain rate, in./min.	0.005			
Water content, %	33.8			
Wet density, pcf	113.0			
Dry density, pcf	84.4			
Saturation, %	93.5			
Void ratio	0.9590			
Specimen diameter, in.	2.40			
Specimen height, in.	5.32			
Height/diameter ratio	2.22

Description: Grey, very soft (R1) silty sandstone
